Investigation Report

AX002-0/02
October 2010

Type of Event: Accident
Date: 10 July 2002
Location: Werneuchen
Aircraft: Civil Air Transport, Fixed Wing
Manufacturer /Type: Saab Aircraft AB / Saab 2000
Injuries to Persons: One passenger slightly injured
Material damage: Aircraft seriously damaged
Third party damage: None
Source of information: Investigation by BFU

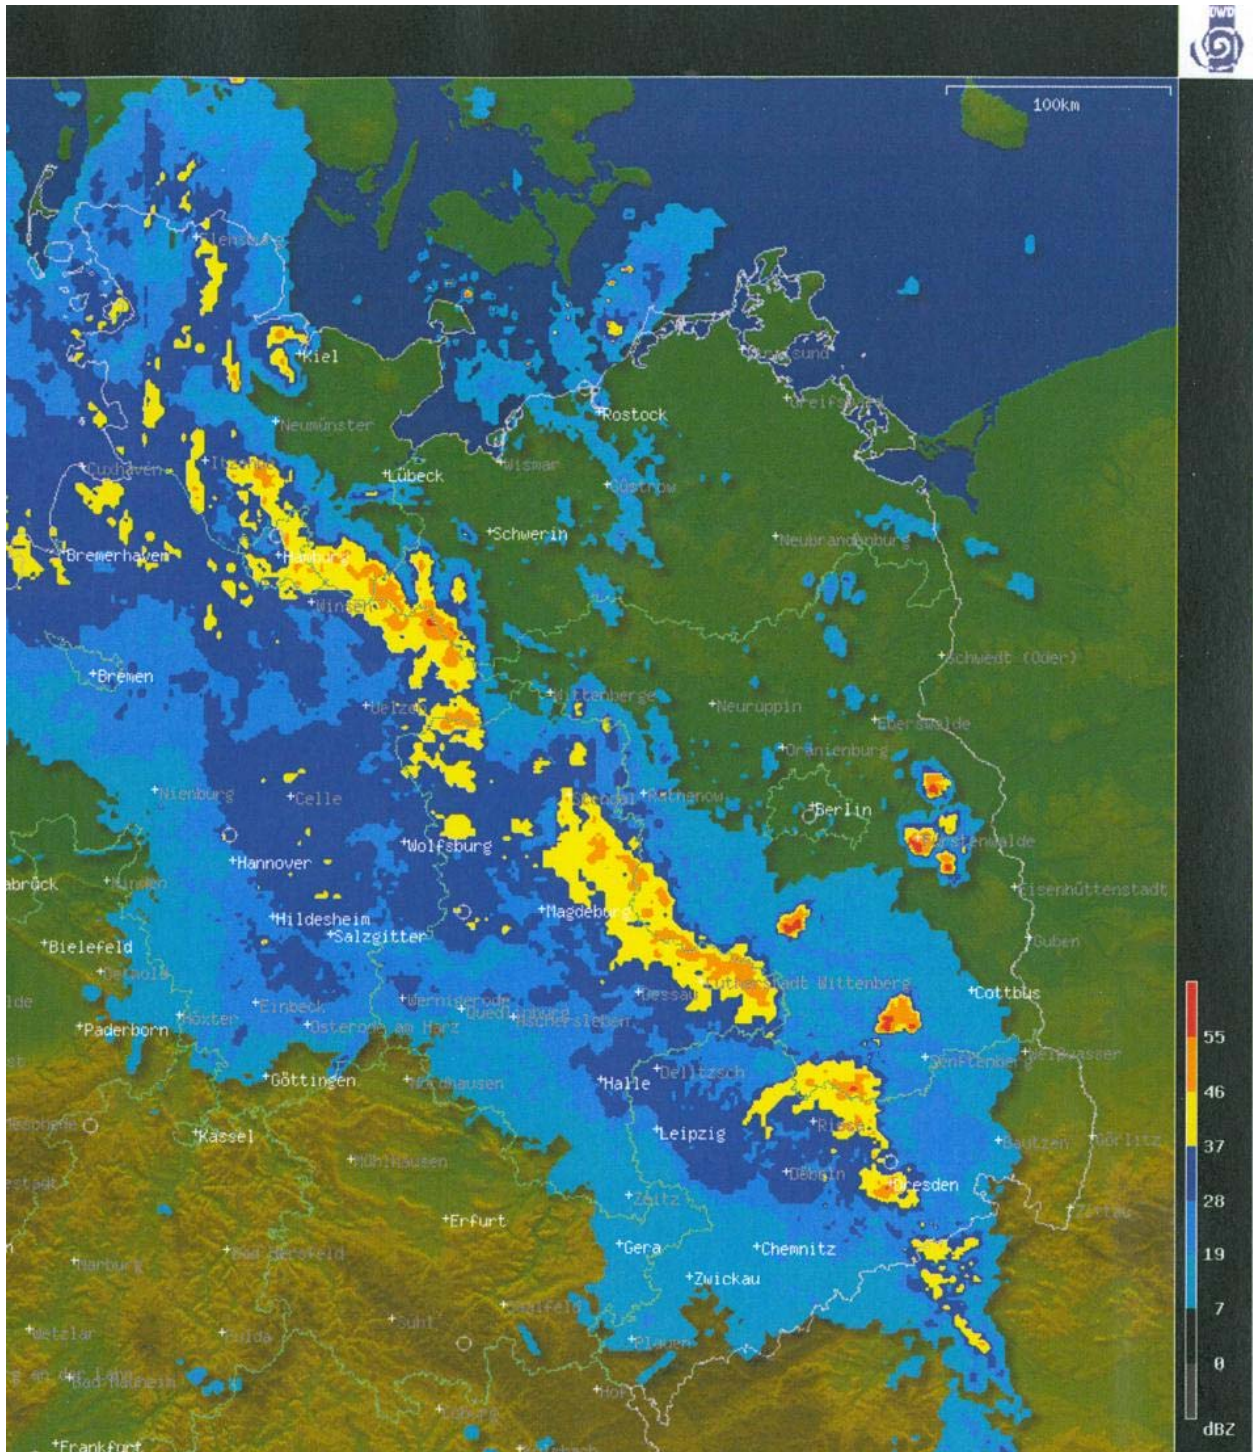
Extract from the weather radar picture taken at 17:43 UTC (1943 hrs local), precipitation intensity (dBZ)

The weather radar image for 17:43 UTC shows that, at about the time the METAR report was assembled, there still were actual CAVOK conditions at Berlin Tegel. However, at this time the cold front was about 30 km southwest of the airport. In the hour previous, the front had advanced more than 100 km to the northeast. The BFU is of the opinion that it is not understandable why the TREND report issued at this time still included the report NOSIG, i.e. a forecast that the situation would remain unchanged for the next two hours.

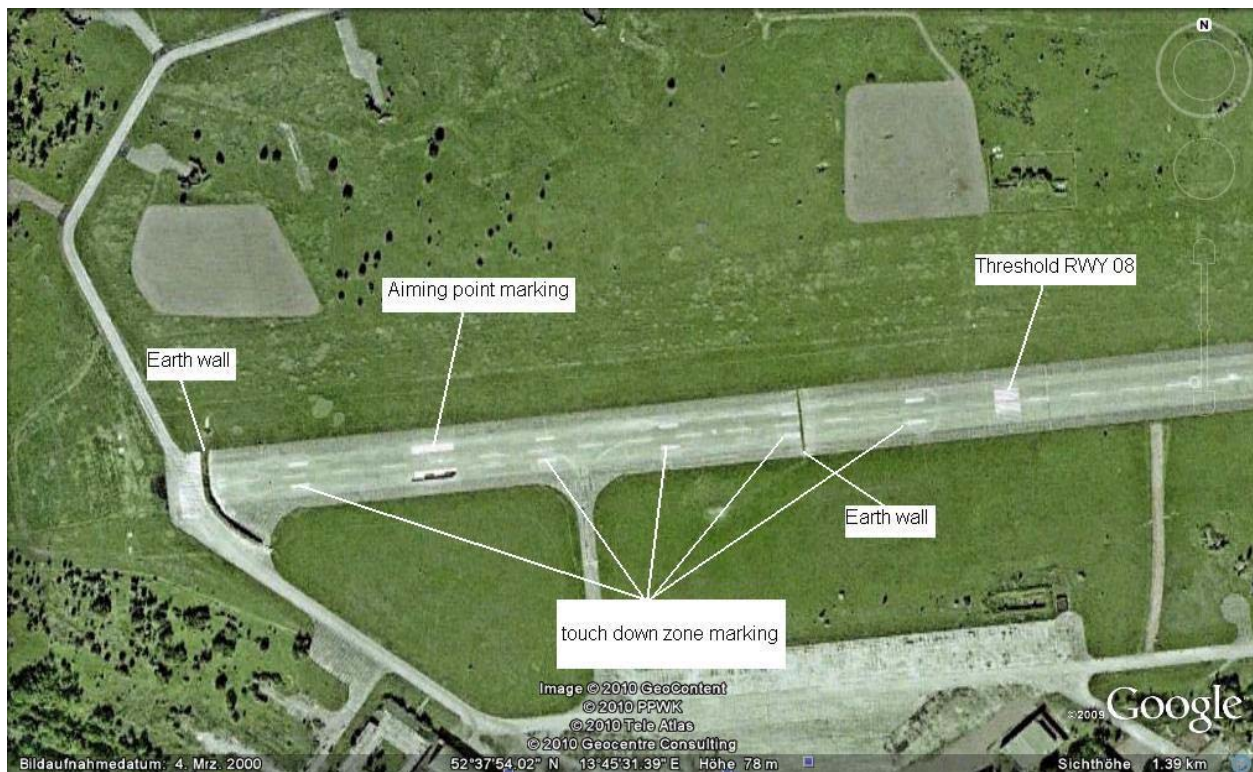
As a precaution against unauthorised access, the aerodrome operator was given permission by the regional Civil Aviation Office to erect an earthen wall no more than four metres high at the western end of the ex-military airfield. In addition, a 70 cm high wall of heavy clay was placed across the entire width of the runway about 235 m west of the threshold to Runway 08 and about 770 m from the western end of the ex-military airfield.

Aerial view of the aerodrome west end, earth wall and wall as seen in 2000

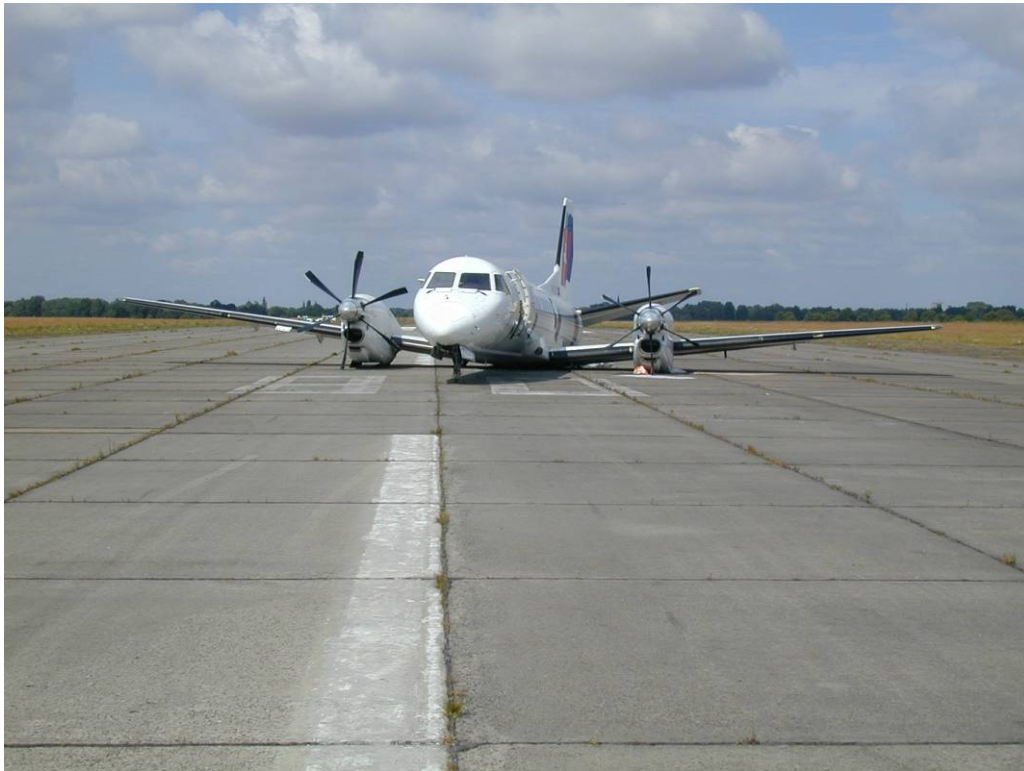
View of the crash site looking west.

In addition to the damage to the fuselage lower surface, the propellers and engine cowls, the fuselage showed evidence of structural deformation.

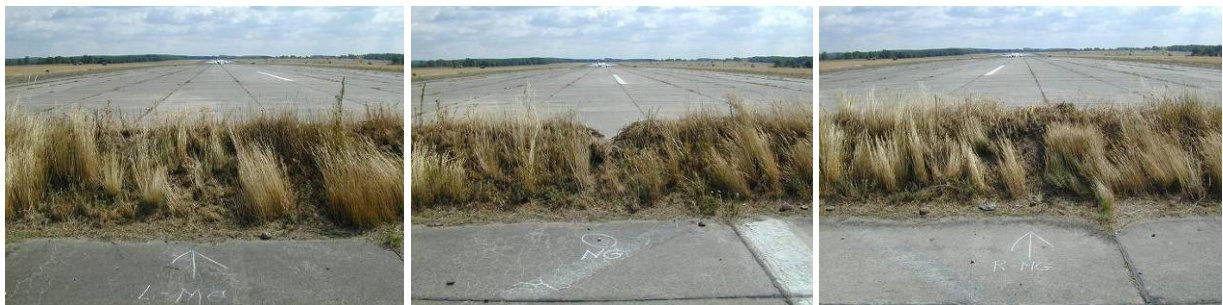
The west side of the approximately 70 cm high earth wall with impact marks: left, that of the left main landing gear; centre, that of the nose gear; right, that of the right main landing gear.

On the western part of the concrete, about 290 m before the earth wall, tracks of all three landing gears were found leading all the way into the earth wall. The aircraft had touched down about 520 m prior to the threshold of the approved section of Runway 08.

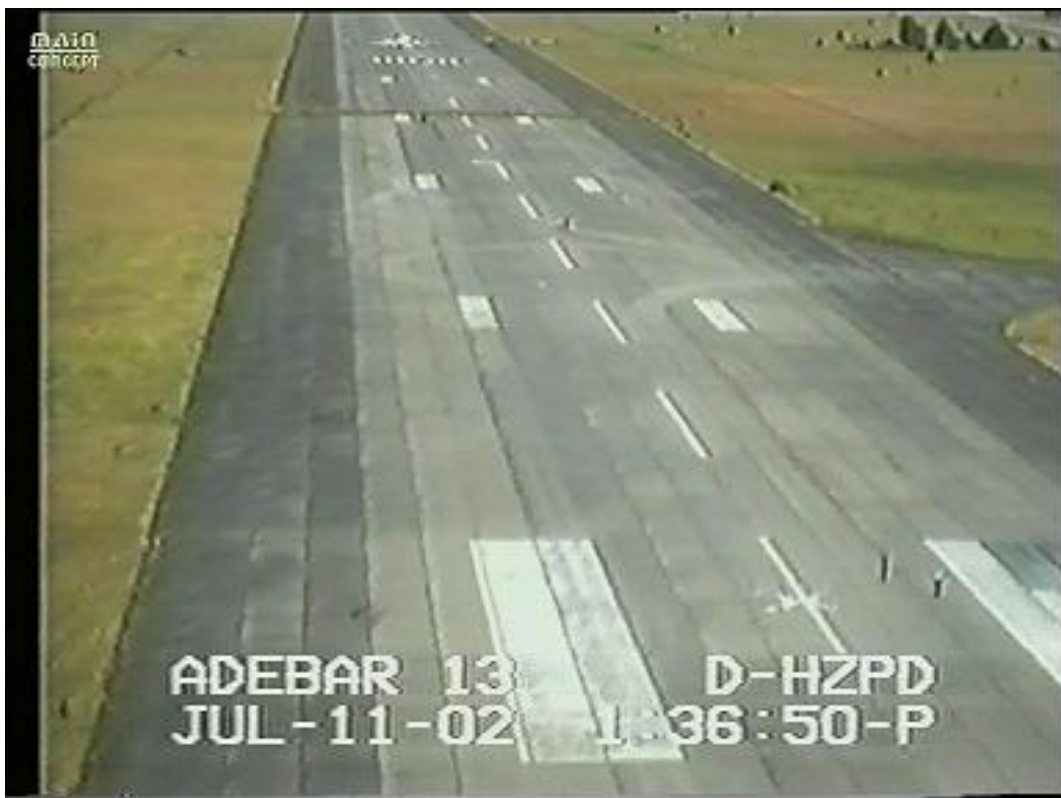
View of the runway shortly prior to over-flying the aiming point markings of the original Runway 08. In the background the earth wall, after that the runway threshold markings on the approved Runway 08, and the position of the aircraft.
 Film still: Police

The low earth wall running across the concrete runway was poorly visible and not seen by the crew. In the opinion of the BFU, under the circumstances (lighting conditions, expectations, urgency of the situation) the earth wall was not recognisable as an obstacle.

- The markings on the disused portion of the old full-length runway had not been removed, nor had the disused portion been marked as such.
- The touchdown zone markings on the old full-length runway were still in good condition, and misled the Saab pilots to use this as a touchdown target marker.
